**NO FURTHER ACTION UNDER
COMPREHENSIVE ENVIRONMENTAL
RESPONSE, COMPENSATION,
AND LIABILITY ACT
STUDY AREA P19
CLEARING, TRACKED ROAD**

1. AGENCY USE ONLY (Leave blank)		2. REPORT DATE 4/12/95	3. REPORT TYPE AND DATES COVERED Final No Further Action Decision Document	
4. TITLE AND SUBTITLE No Further Action Decision Document for Study Area Pl9, Clearing, Tracked Road, Fort Devens Sudbury Training Annex			5. FUNDING NUMBERS C

13. ABSTRACT (Maximum 200 words) This report is a Final No Further Action Decision Document for Study Area Pl9, Clearing, Tracked Road at the Fort Devens Sudbury Training Annex located in Sudbury, Massachusetts. This NFADD explains why no further investigation or remediation is required at Area Pl9. The NFADD provides a review of the site reconnaissance and soil sampling results to applicable human health and ecological standards.

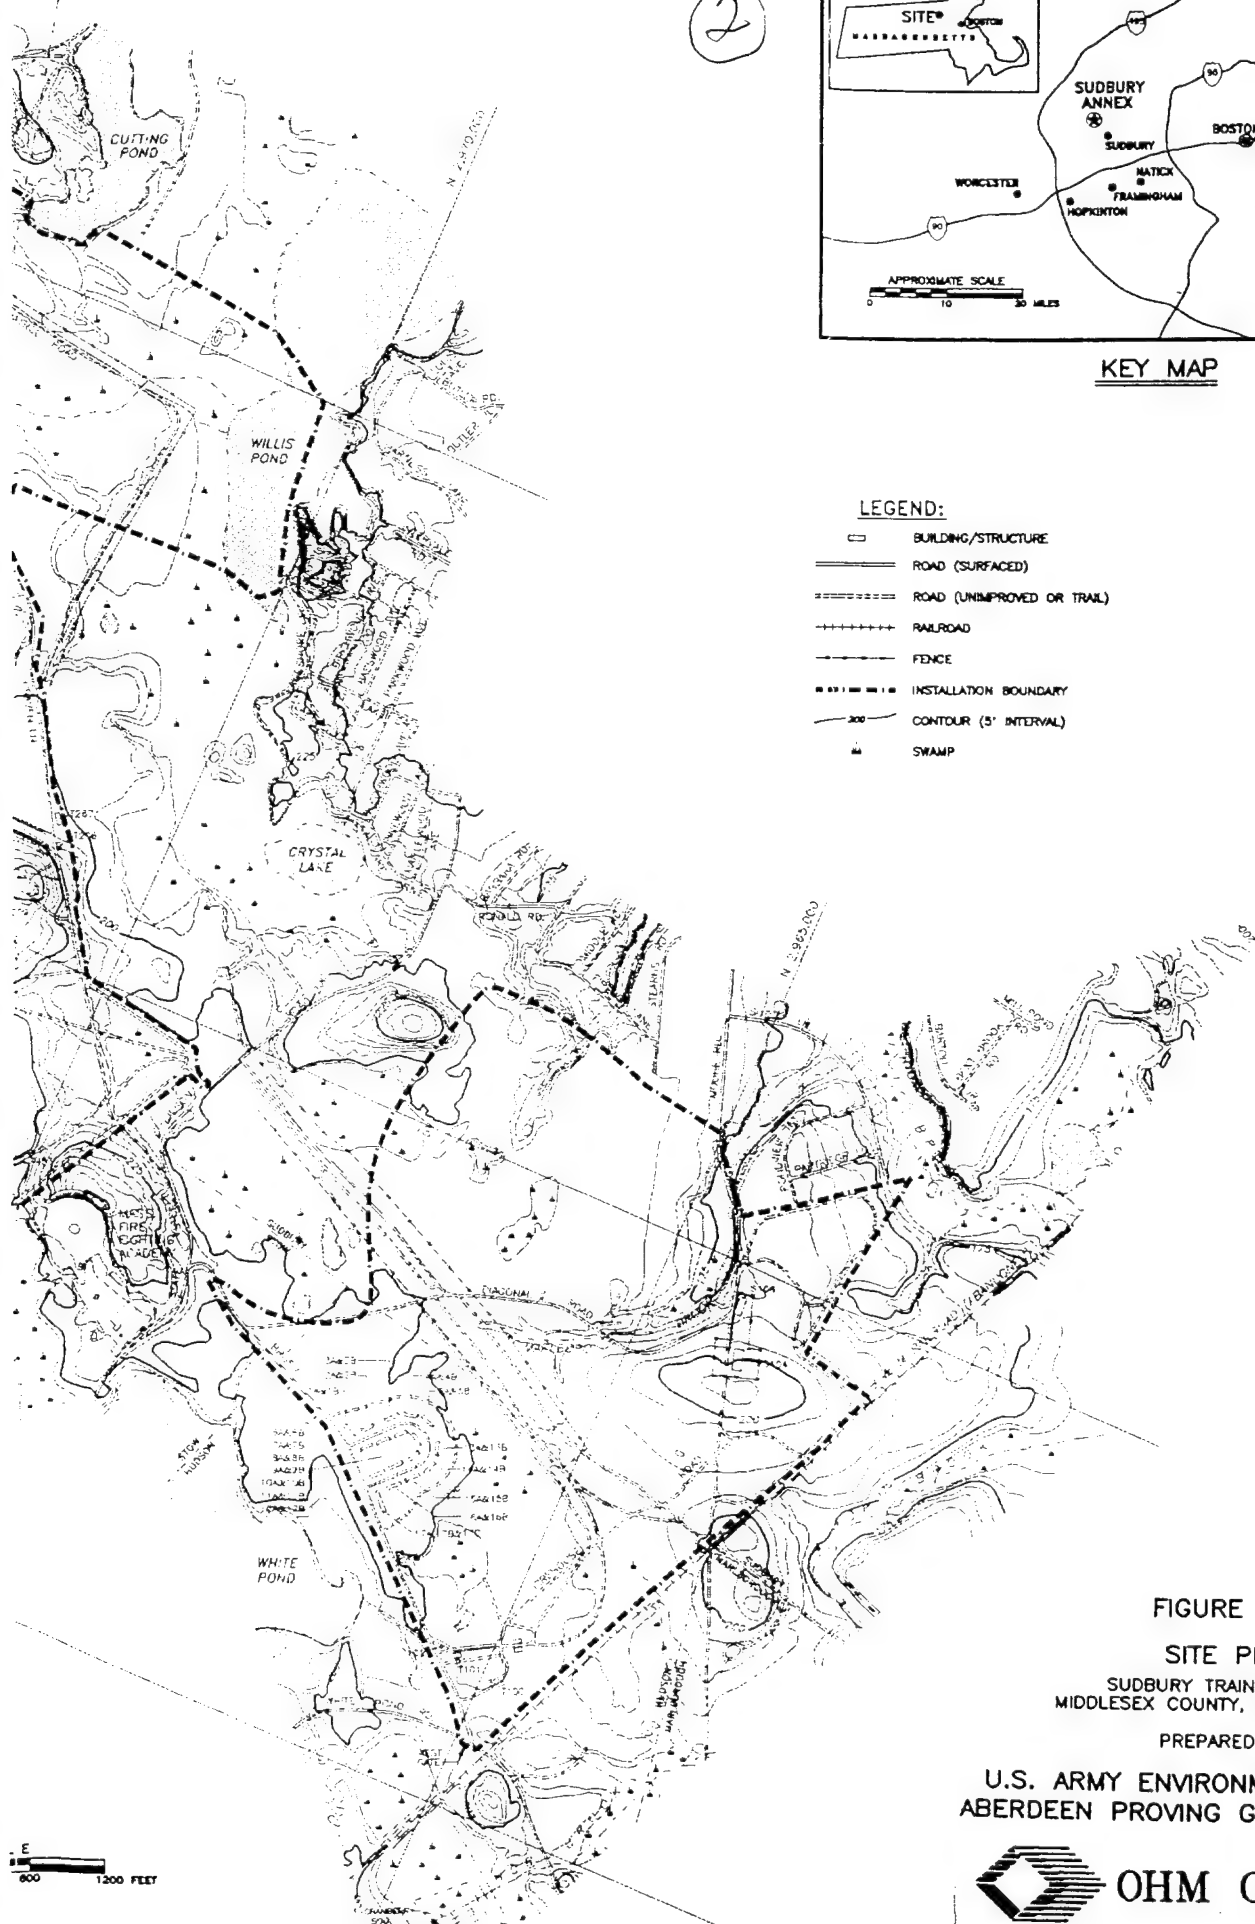
FIGURE 2-1

The Sudbury Training Annex is located 20 miles west of Boston, 12 miles northwest of Natick, Massachusetts and 2 miles northwest of the town of Sudbury in Middlesex County, Massachusetts. The installation is located in the Maynard, Massachusetts 7½-minute United States Geological Survey (USGS) quadrangle map. Figure 2-1 presents the site map.

SITE PLAN

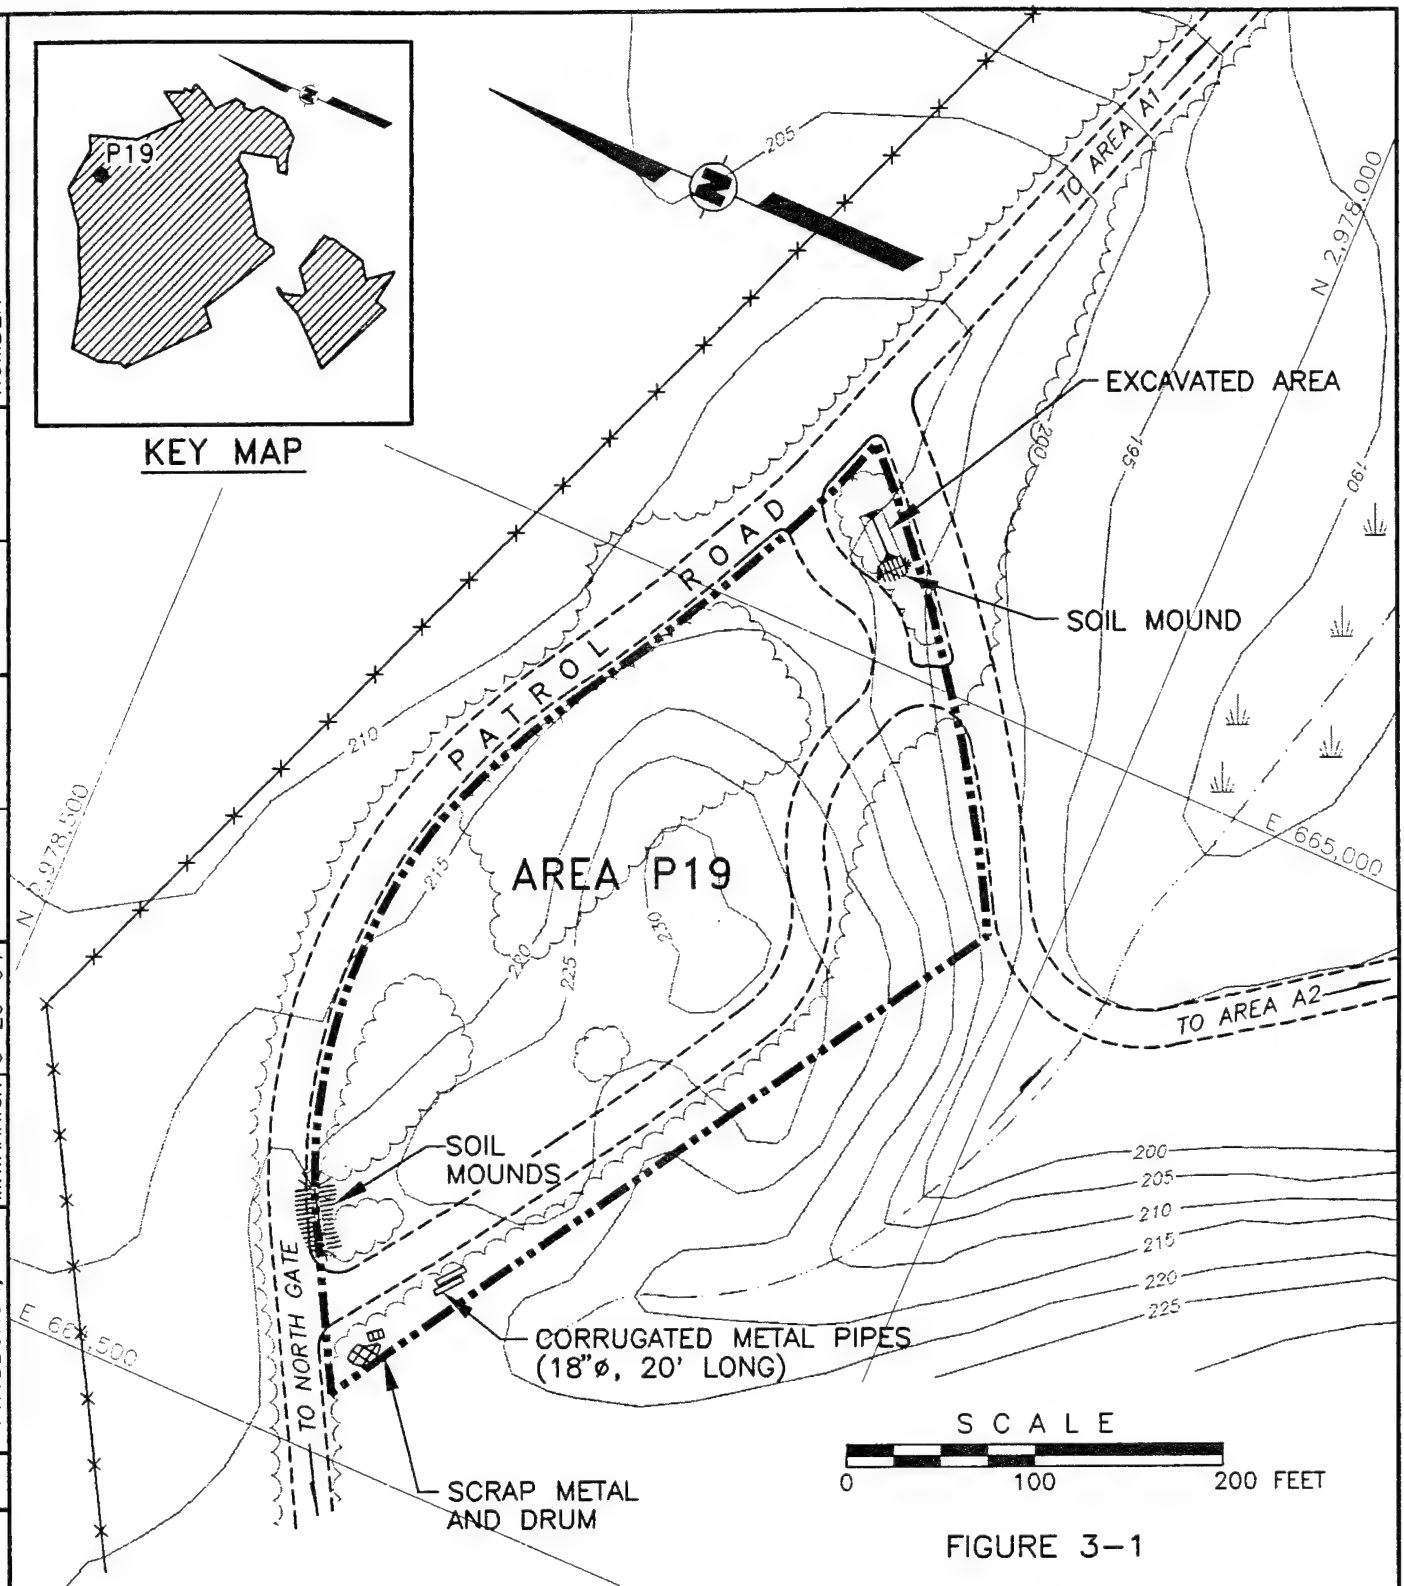
FIGURE 3-1

Area P19 is located near the northern border of the installation on the south side of Patrol Road. The area is 500 feet north of Area A2 and 1,500 feet northeast of the North Gate. Figure 3-1 presents a map of the area. The surficial geology of this area has been classified as ground moraine (Hansen,1956). The area is a wide clearing situated on a small hill. The clearing is visible on aerial photographs.

Several small mounds, trenches, and pits were noted in the area which were believed to be the remains of fighting positions left by military training units. Record searches do not indicate disposal activities in this area.

AREA P19
SITE MAP
SUDBURY TRAINING ANNEX
MIDDLESEX COUNTY, MASSACHUSETTS

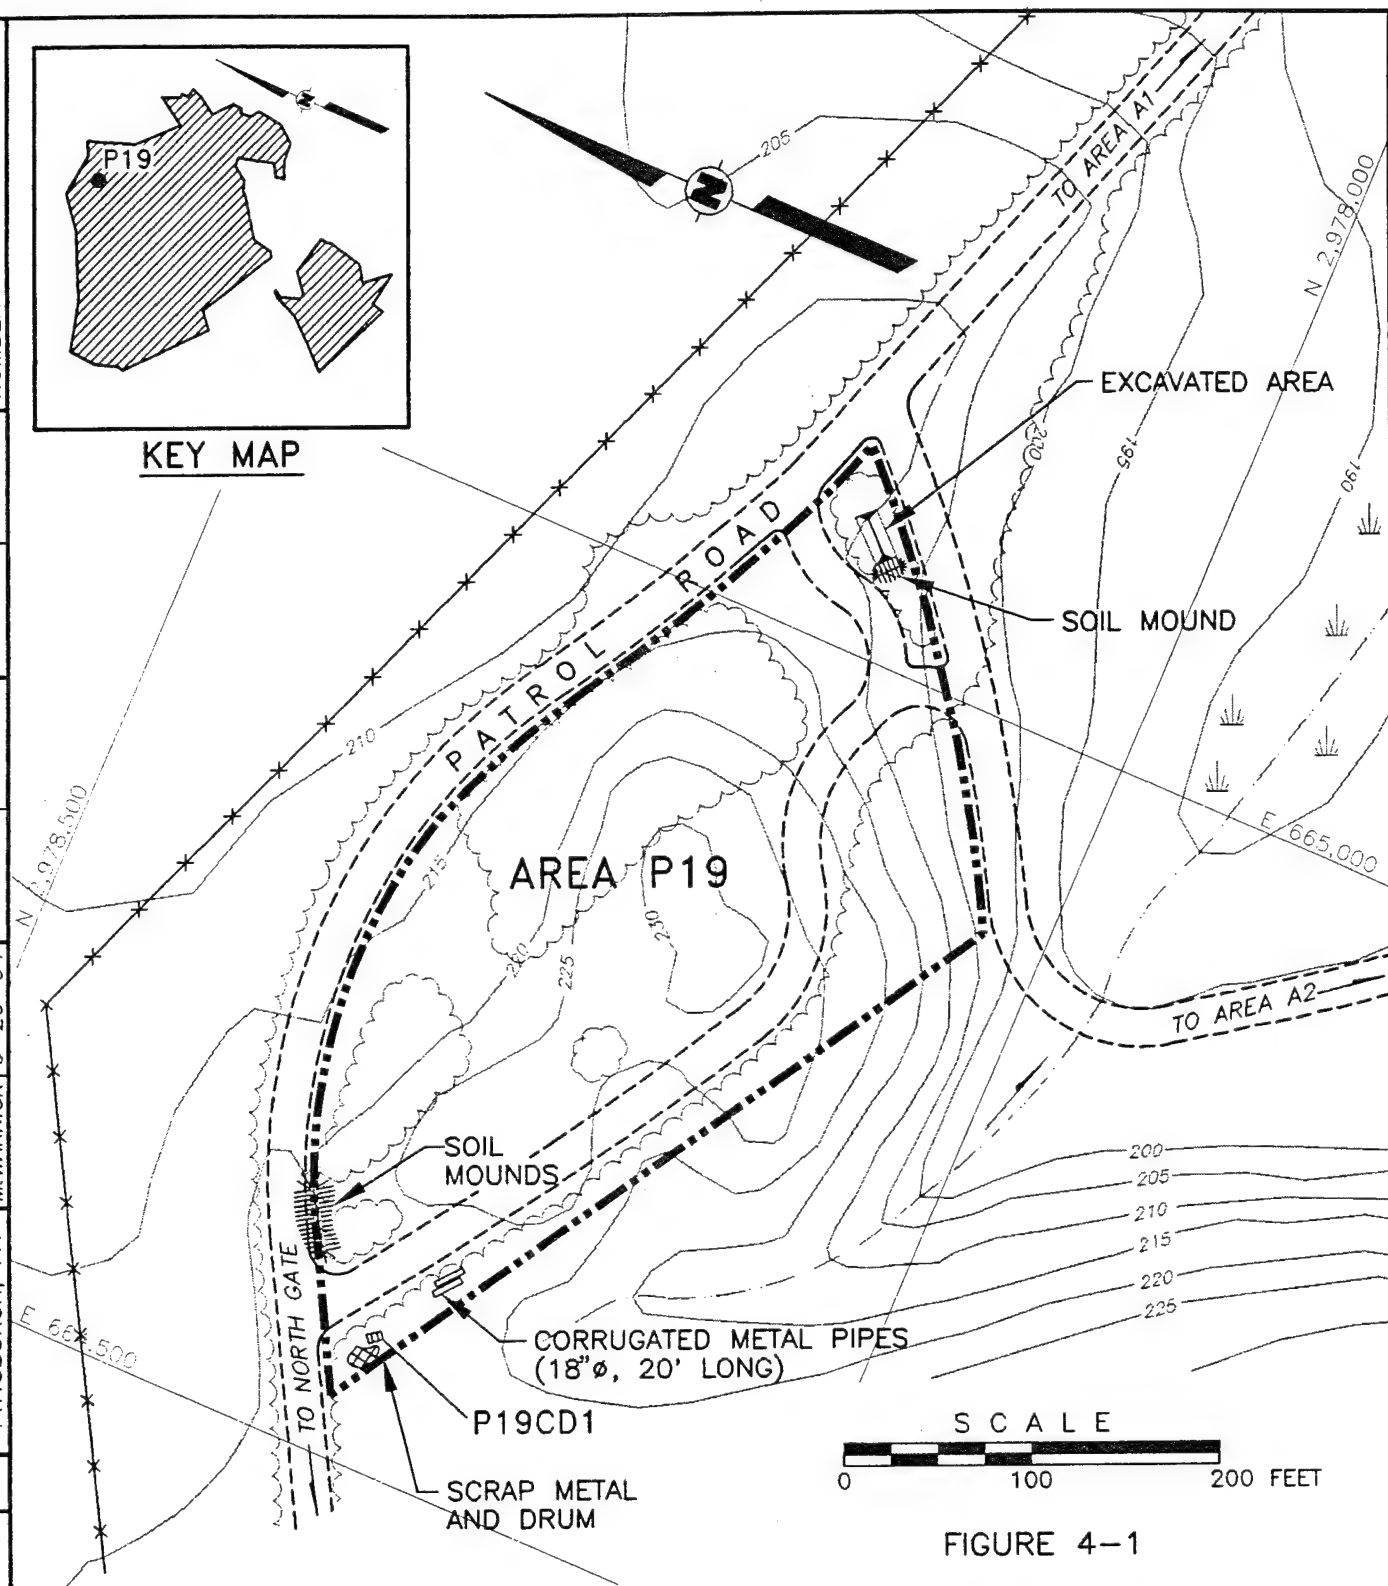
FIGURE 4-1

The single drum was removed and placed in a staging area at the old MFFA. During the Phase II investigation one confirmatory sample, P19CD1, was collected and analyzed for TCL volatile and semi-volatile organics, pesticides/PCBs and TAL metals. The sample location is presented in Figure 4-1. No staining, unusual odors, or PID or radiological readings were noted during sampling. A complete list of positive detections from Area P19 is provided in Table 4-1. The pesticides, DDT and DDE, were positively detected at 0.0341 and 0.0751 $\mu\text{g/g}$. Among the positive metal detections, arsenic, barium, cobalt, lead, and potassium were detected above their respective 95% UCL for background soils, however arsenic, barium, beryllium, cobalt, and potassium are not considered contaminants of potential concern since their detections were within the range concentrations in the background samples. Selenium was detected at 0.64 $\mu\text{g/g}$ and does not have a background level.

AREA P19 SITE MAP
AND PHASE II SAMPLE LOCATION
SUDBURY TRAINING ANNEX
MIDDLESEX COUNTY, MASSACHUSETTS
